BUILDING 4176

CONDITION SURVEY

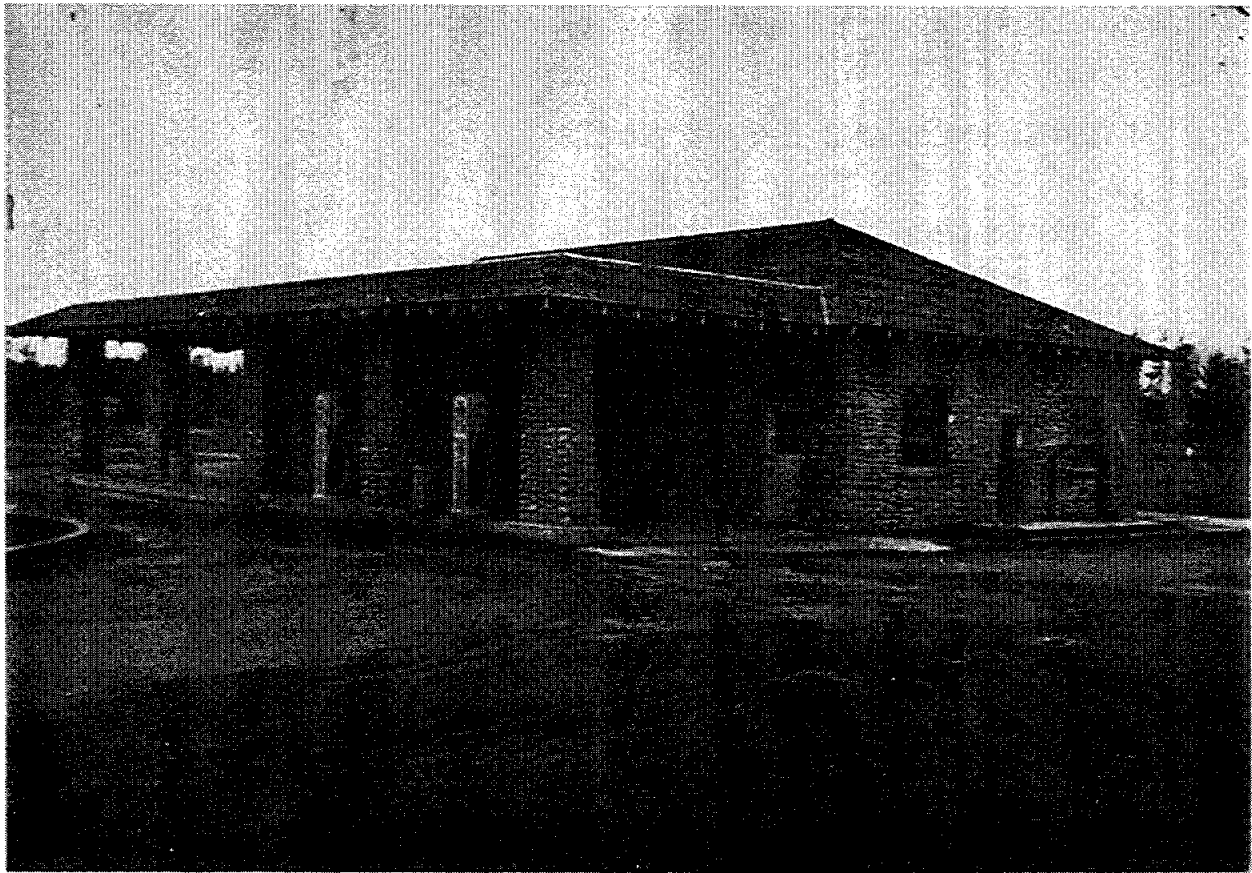
Building 4176 was constructed in 1937 as a service station. This is the only building constructed of field stone during that era. (Fieldstone was used on only one other, earlier building; the main gate, which was formerly located near the service station but moved in 1957.)

The service station is currently in good condition but will need roof replacement shortly to defer deterioration.

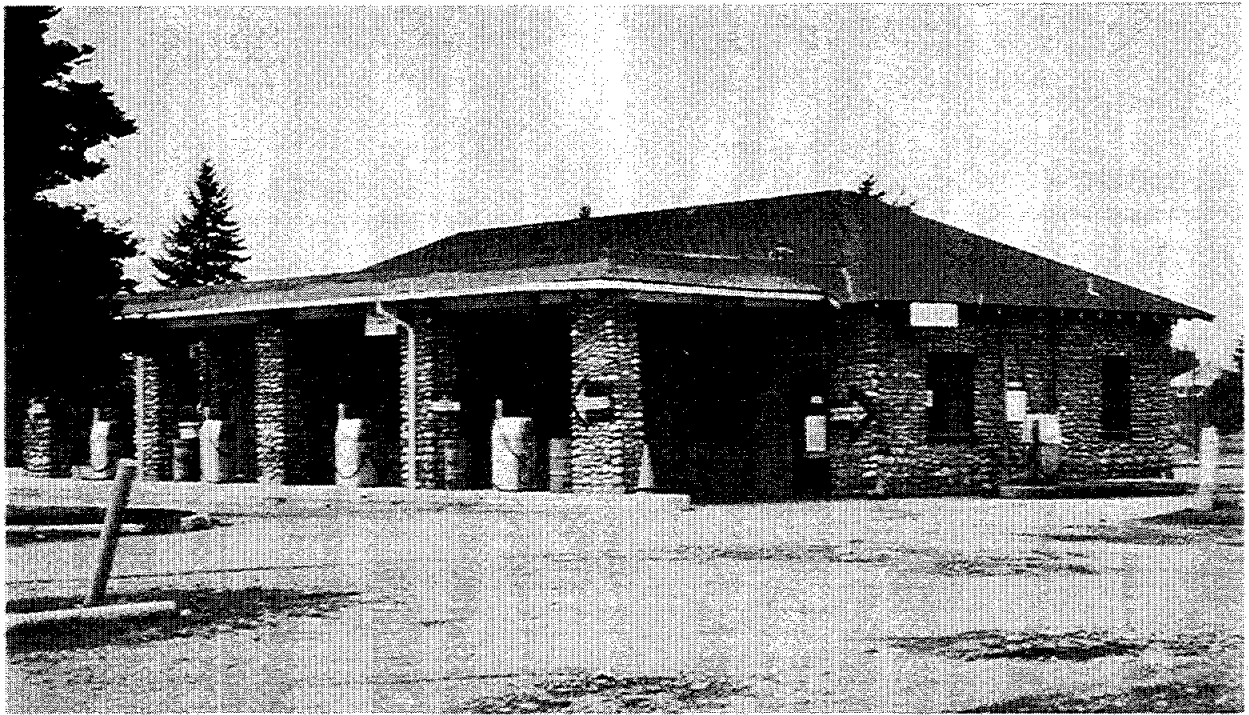
LEAKING, PEELING PAINT

1. Yellow/black arrows painted directly onto stone walls.
2. Roof needs replacing.
3. Much peeling paint at underside of canopy; check for roof leaks. Canopy may be sloping back towards building.
4. Plywood roof sheathing is rotting at gutters. Exposed edges of plywood here is poor detail.
5. Shiplap roof sheathing also rotting at overhangs. Inadequate ventilation.
6. Rafter tails need new paint.
7. North wall: Diagonal crack from top corner of door to roof.
8. Windows: Sash rusting. Remove paint from outside face of glass. Broken panes.

3. PAINT ON CANOPY

- a. Ensure that there are no leaks remaining in canopy.
- b. Scrap and sand all wood surfaces on underside of canopy.
- c. Reattach loosened soffit boards and trim.
- d. Prime and repaint.
